# Performance Evaluation of Shear Connectors Embedded in Ultra-High Performance Concrete as Part of a Bridge Repair Method

Dominic Kruszewski, PhD

University of Connecticut, 2018

A Dissertation

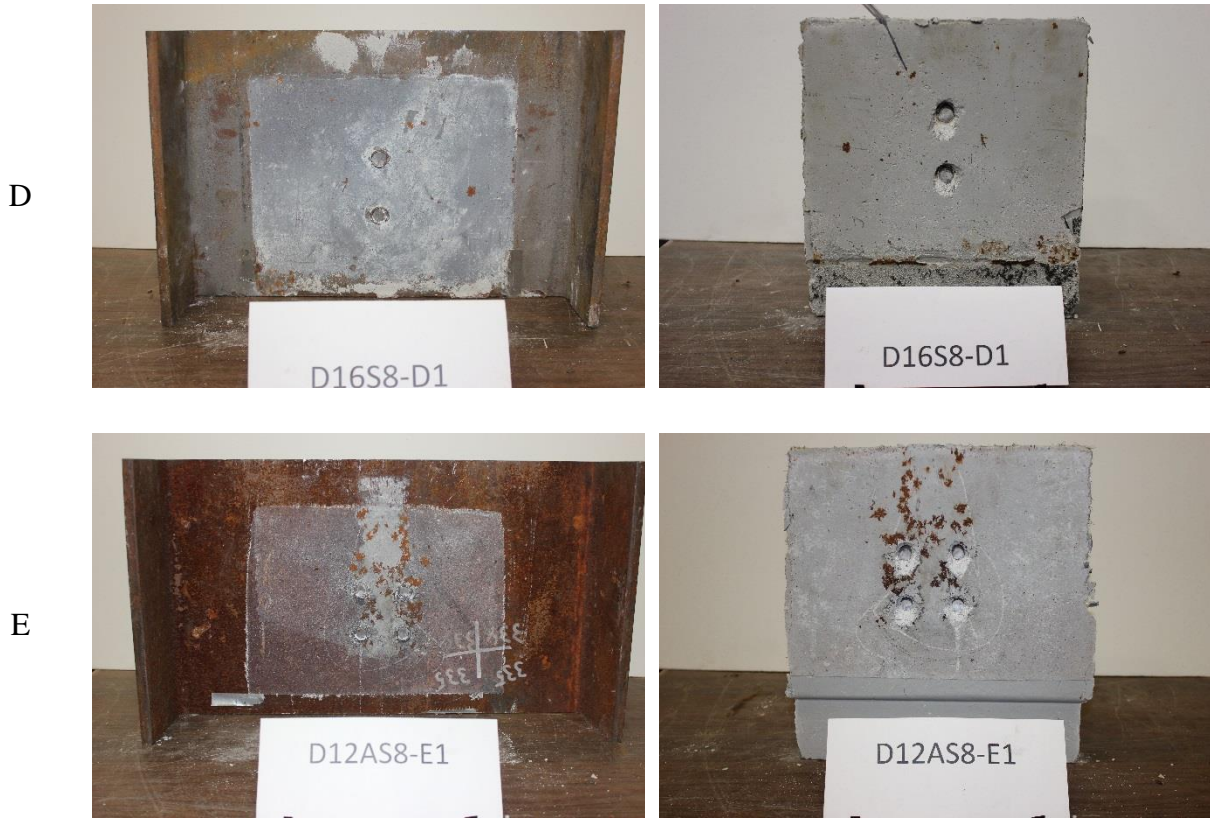
**Fig. 14.** Summary of Failed Samples for All Stud Arrangements

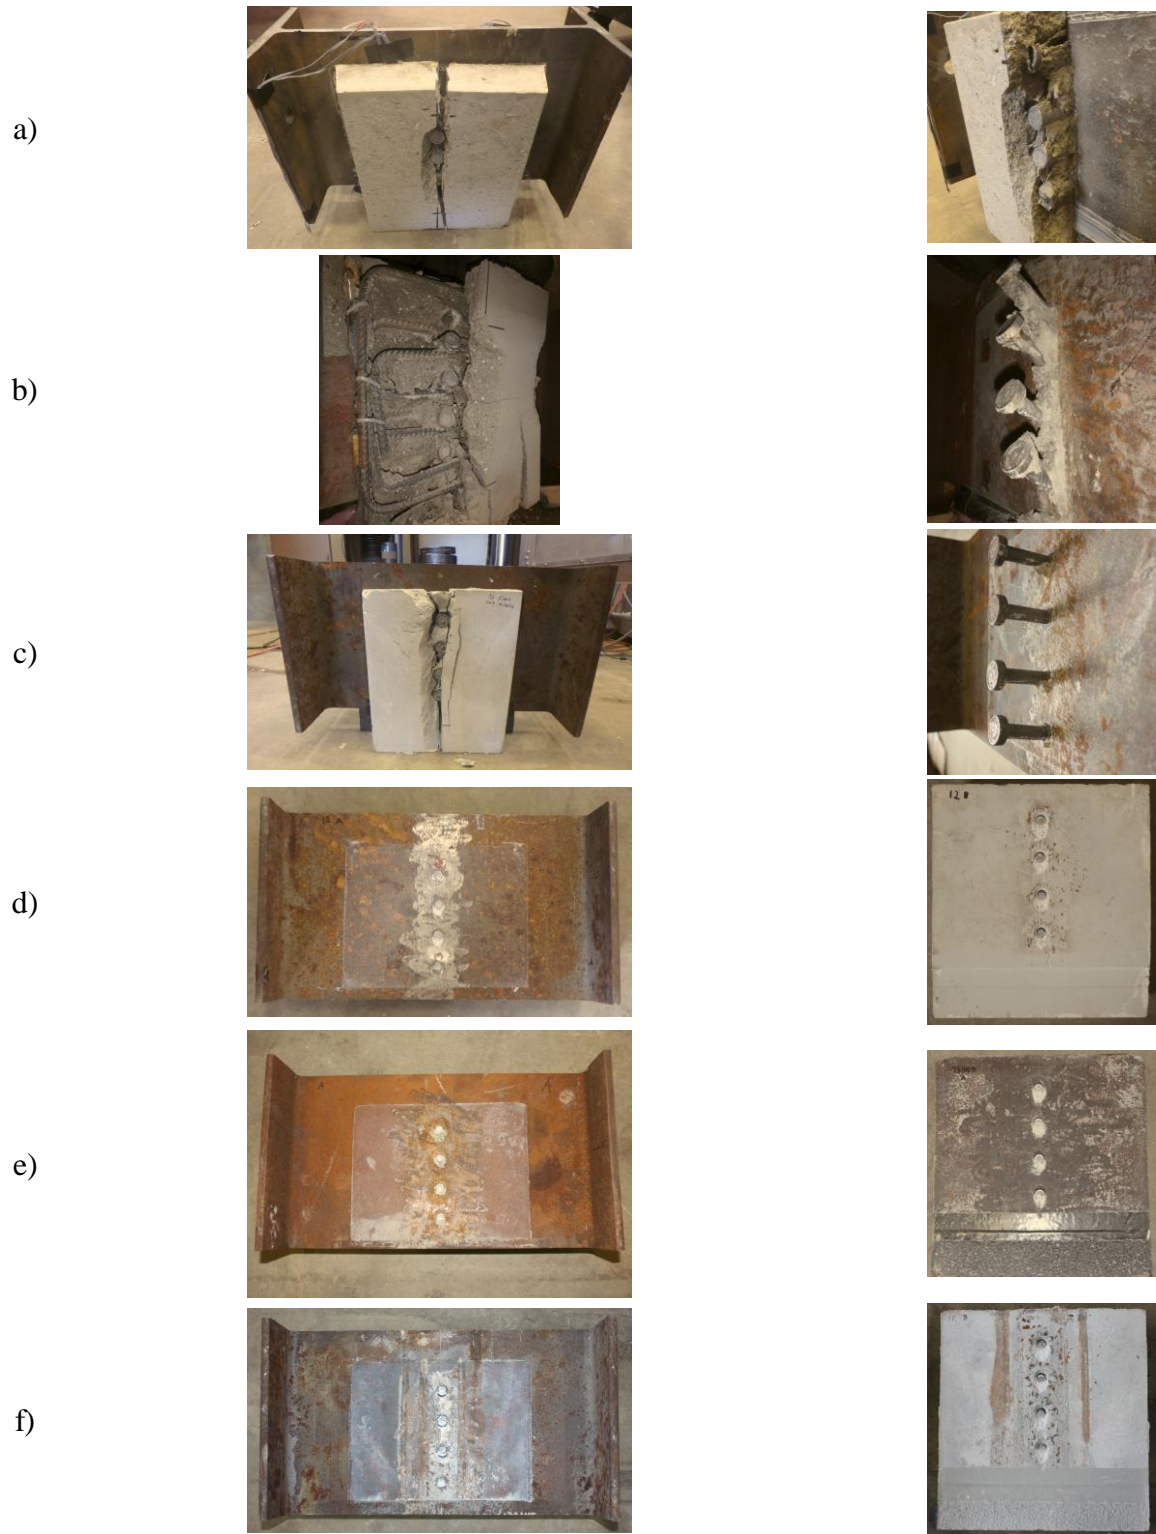
**Fig. 21.** Failed specimens: a) Unreinforced HSC, b) Reinforced HSC, c) UHPC-B, d) UHPC-A\_Heat, e) UHPC-C and f) UHPC-D

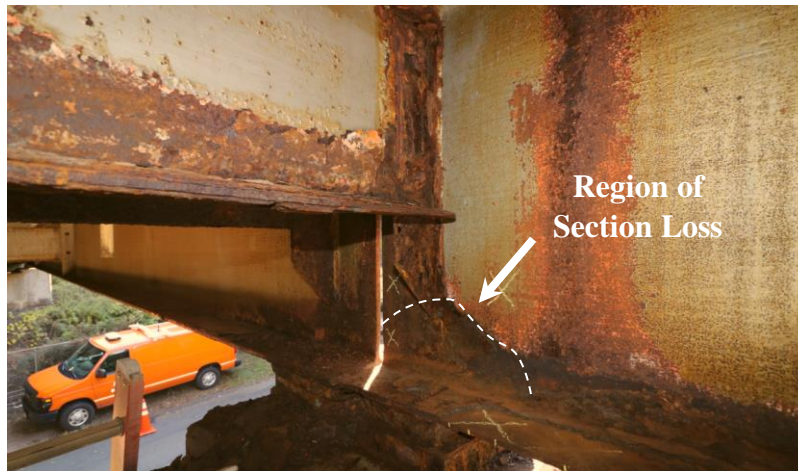
**Fig. 1.** Typical girder end corrosion at the bearing.
